Green Cross for Safety® Awards 2025 Finalist | Innovation

Puget Sound Energy Case History

Wind Turbine Nacelle Maintenance Challenges

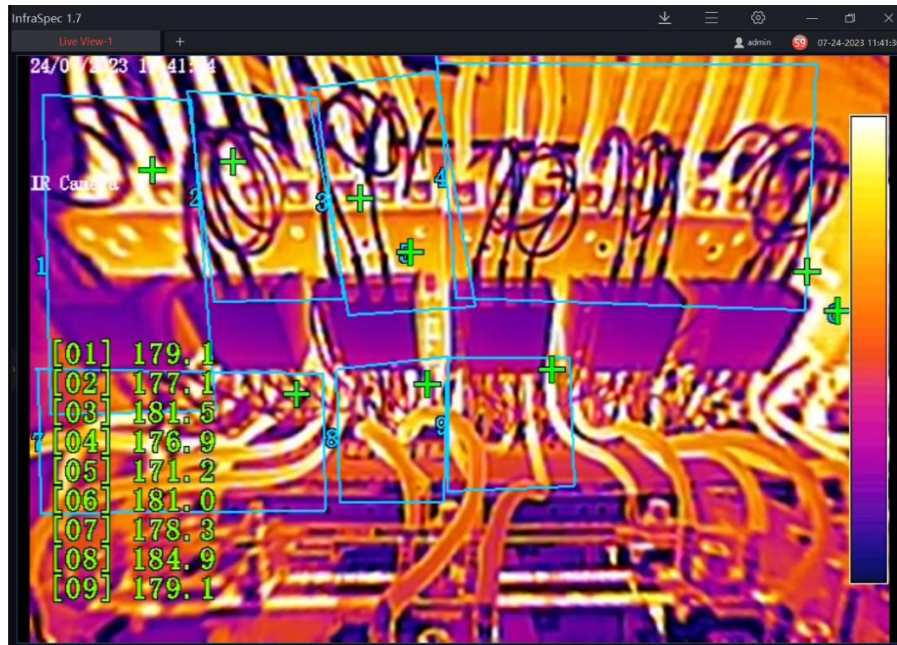
The TC-90™ turned out to be a game changer for PSE as it allowed safe viewing and monitoring of 6 of the 12 contactors including the contactors, wires and terminations, while running at full power. It delivered very valuable data in real time which had never been available to them in the past. This, in turn, allowed them to find that the lead wires connected to the contractors as well as the contactors themselves were operating far above their respective manufacturers rating. Temperatures were consistently reaching over 110°C and a few occasions even exceeded 180 °C whereas the manufacturer's rating is only 90°C and 75°C respectively. They could not have discovered this without this camera system.^[7]

Temperature exceeding 180°C which is double the manufacturer's specifications

Understanding this was a design flaw in the system, PSE addressed the problem by mitigating the risk. They installed din rail spacers to improve airflow around contactors and installed heat exchangers on the outside of the cabinet door. This is expected to reduce the failure rate and severity of failures by improving the operating conditions of the PFC components closer to within their design limits and in turn reduce turbine downtime as well as unscheduled repair visits by technicians. The overall effectiveness of this retrofit is still being determined on a subset of turbines however short term monitoring has confirmed an average temperature reduction of 25°C. While this doesn't fix the root cause of the problem, it allows them to closely monitor the situation and manage the issues before they can get out of hand. They are also able to easily identify any new anomalies caused by workmanship or damaged/degraded components. The image below is an example of an individual contactor that needs inspected/replaced due to possible worn contacts.

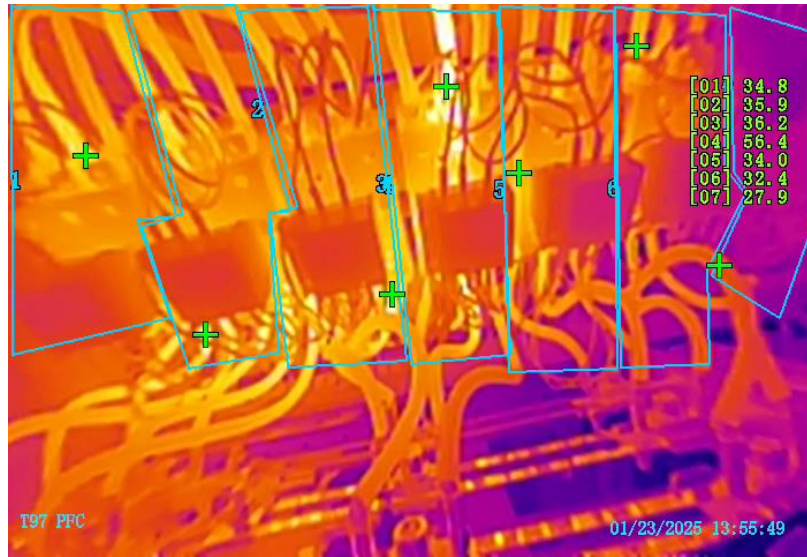
New anomaly identified after retrofit: 20°C temperature differential

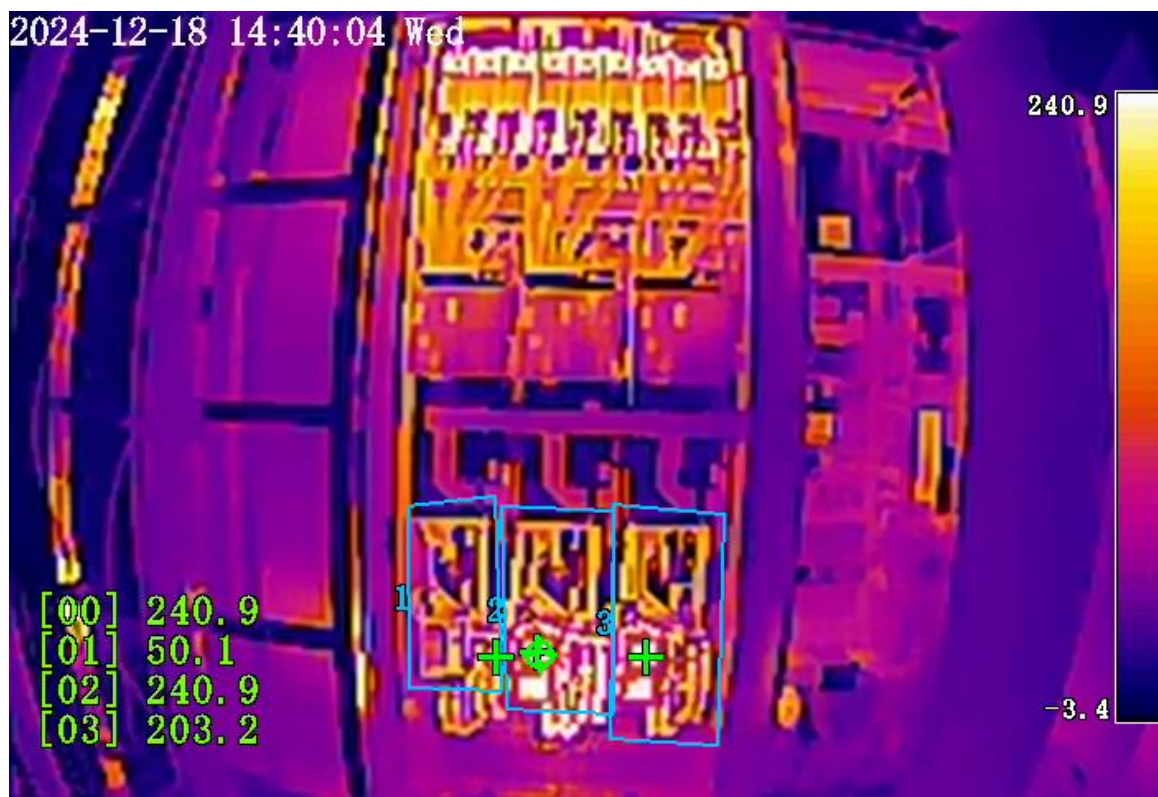
They remotely operated the turbine and within a short time period witnessed temperatures on the body of the fuses continually climb from 60°C up to 240°C before the fuse physically failed (the ceramic housing cracked open). They also saw that the center delta module and reactors were getting hot. The delta module was replaced, however the problem persisted. Further troubleshooting led them to a defective control board that was installed during the initial troubleshooting stage. Once that was replaced, they had no further issues.

Initial view of the converter cabinet with 3 preset boxes. There are 2 fuses in each of the two boxes on the right. Fuse design limits are near 125°C. The left box [01] has no fuses and is 50°C. The right pre-set box [03] shows fuses at 203.2°C. The middle box [02] is running at 240.9° C just before the fuse failed.

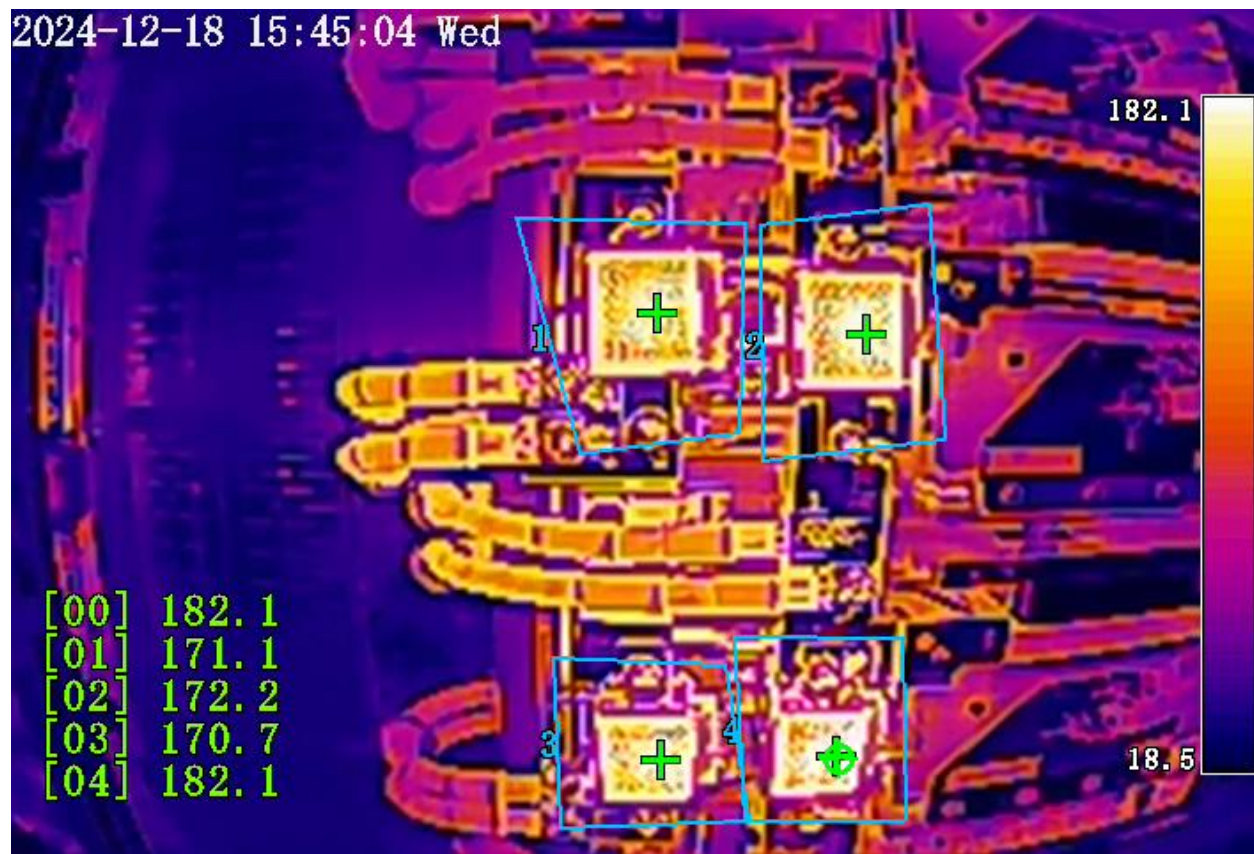
Camera view after being moved closer and rotated to 90 degrees. This image shows four new presets looking at the four fuses in the two hot areas separately. Temperatures rose to 182.1C in a matter of minutes, forcing PSE to stop power before the temperatures rose any higher and before fuses could fail. They also noticed the middle conductors (these are DC cables) were running hot.
