Green Cross for Safety® Awards 2025 Finalist | Innovation

Puget Sound Energy Case History

Wind Turbine Nacelle Maintenance Challenges

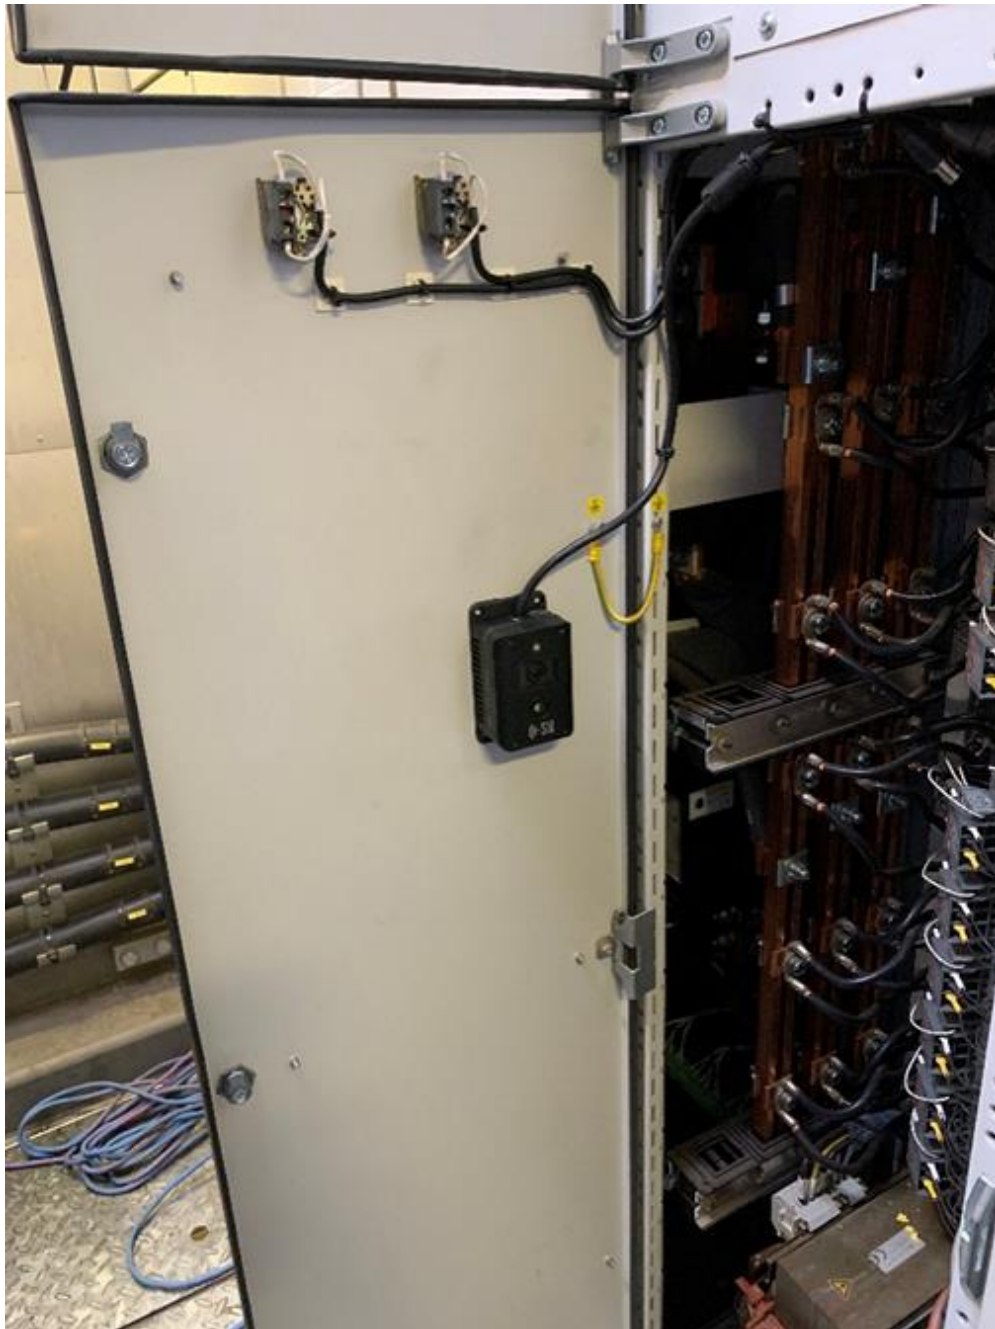
Fig. 1 - The Sytis TC-90™ magnetized to the panel door in the nacelle of a Vestas V80 PFC cabinet at Puget Sound Energy.

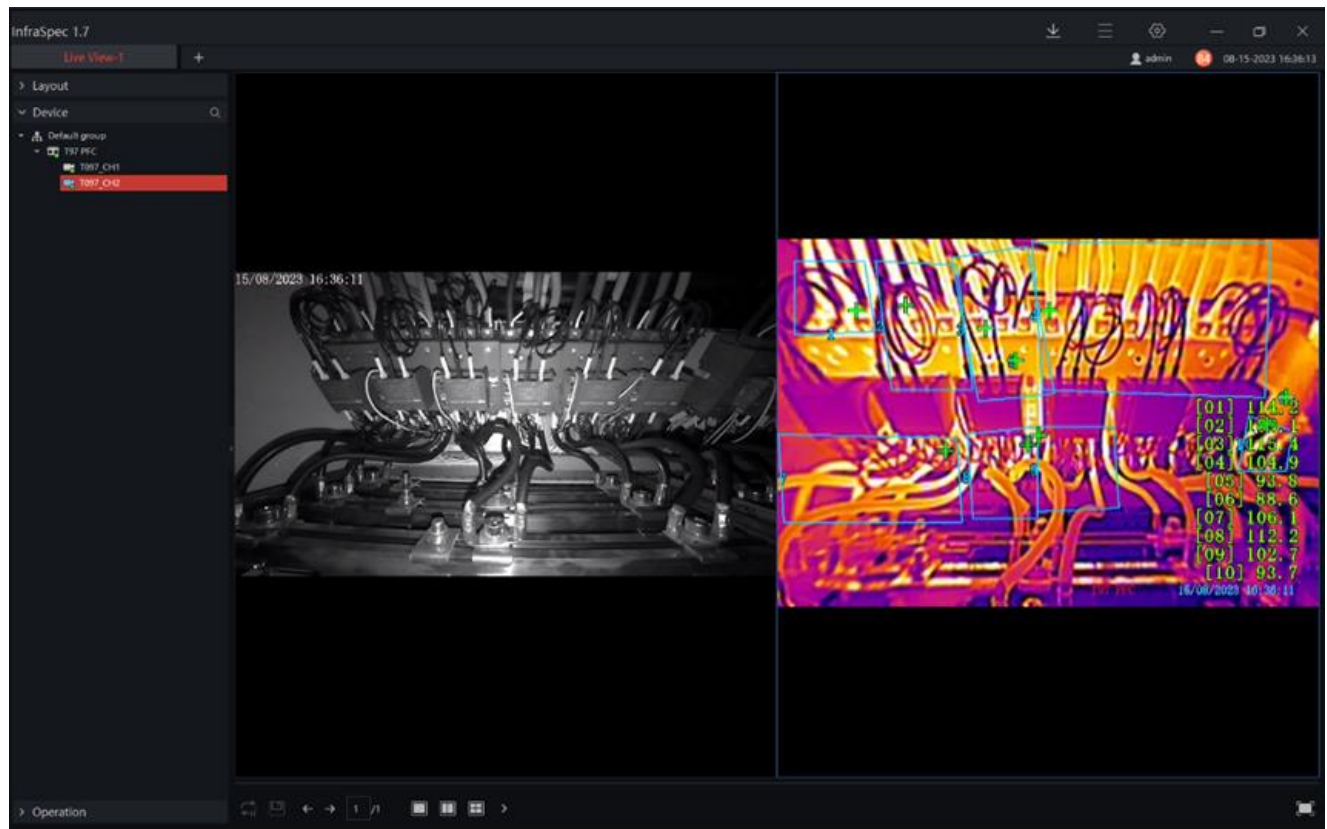
Fig. 2 - Screen shot of live stream showing side by side comparison from the Sytis TC-90™ bi-spectral camera attached to the panel door inside of a Vestas V80 PFC cabinet at Puget Sound Energy.
